INTRODUCTION

Process Engineering, Inc. inspected the customer's Q set evaporators during the mill outage during the week of April 5, 2020. The inspection was performed to find loose or broken internal elements and excessive corrosion activity. All vapor heads, and steam chests and lower liquor boxes were inspected. Major findings were provided to the mill at the time of the inspection. This report includes the major findings and other details of our inspection.

“Q” SET EVAPORATOR

LTV BODY INSPECTION REPORT

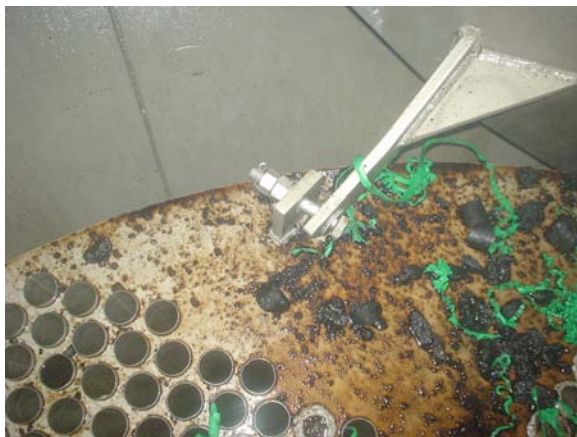
- C1, C2, Q2, Q4 & Q6: The umbrella baffle hold down bolts were loose due to too long bolts. The connection between umbrella leg and heating element lug should be tight to prevent umbrella movement.

**C1 EFFECT
LOOSE UMBRELLA HOLD DOWN BOLT**

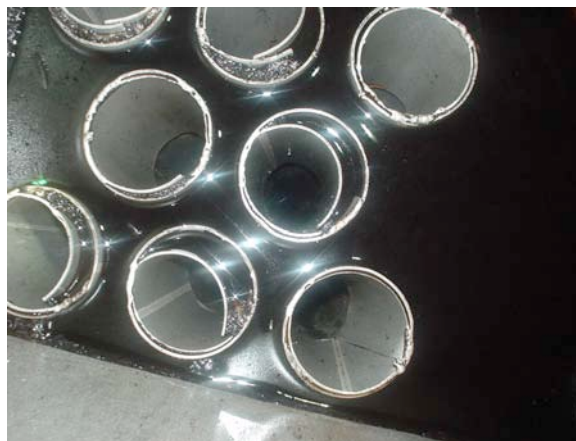
- C1 & C2: Collapsed tube sleeves located in top tube sheet should be removed. Many of these sleeves are restricting flow of the liquor (see photo section)

- Unsecured tube inserts have been installed in the top of tubes in several bodies. These inserts have begun to collapse restricting flow in tubes. It is recommended that these inserts be removed. If inserts are to be used, secure the inserts so liquor cannot get behind them.

**C1 EFFECT
PARTIALLY COLLAPSED TUBE LINERS IN
INTERNAL HEATER**

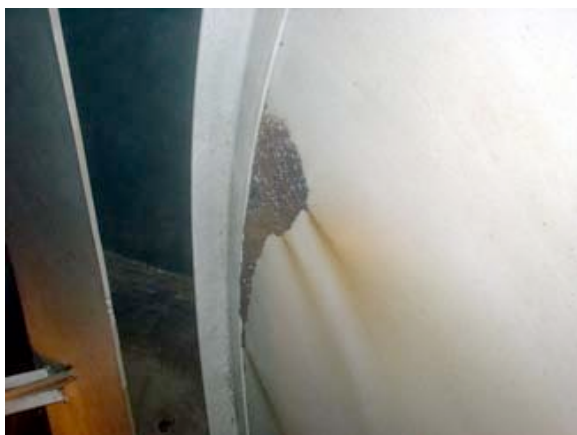
**C1 EFFECT
LIQUOR DEPOSIT UNDER UMBRELLA**

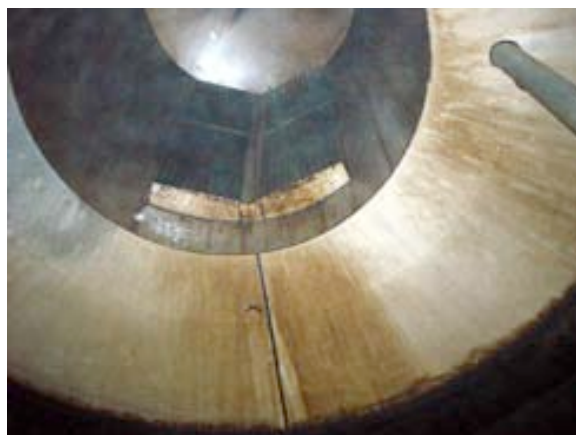
**C1 EFFECT
ENTRAINMENT SEPARATORS**

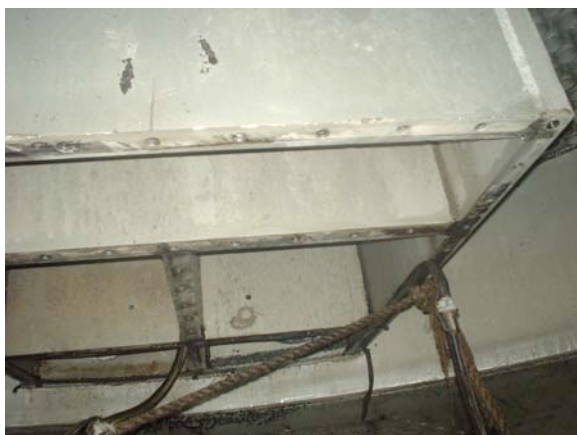
**C1 EFFECT
LIQUOR BOX**

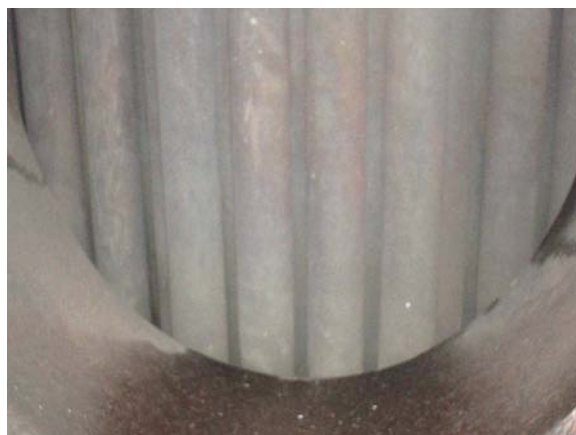
**C1 EFFECT
OUTSIDE OF TUBES**
