Troubleshooting Two Vacuum Problems

Alton Goodwin
Process Engineering, Inc.
Birmingham, AL 35201

INTRODUCTION

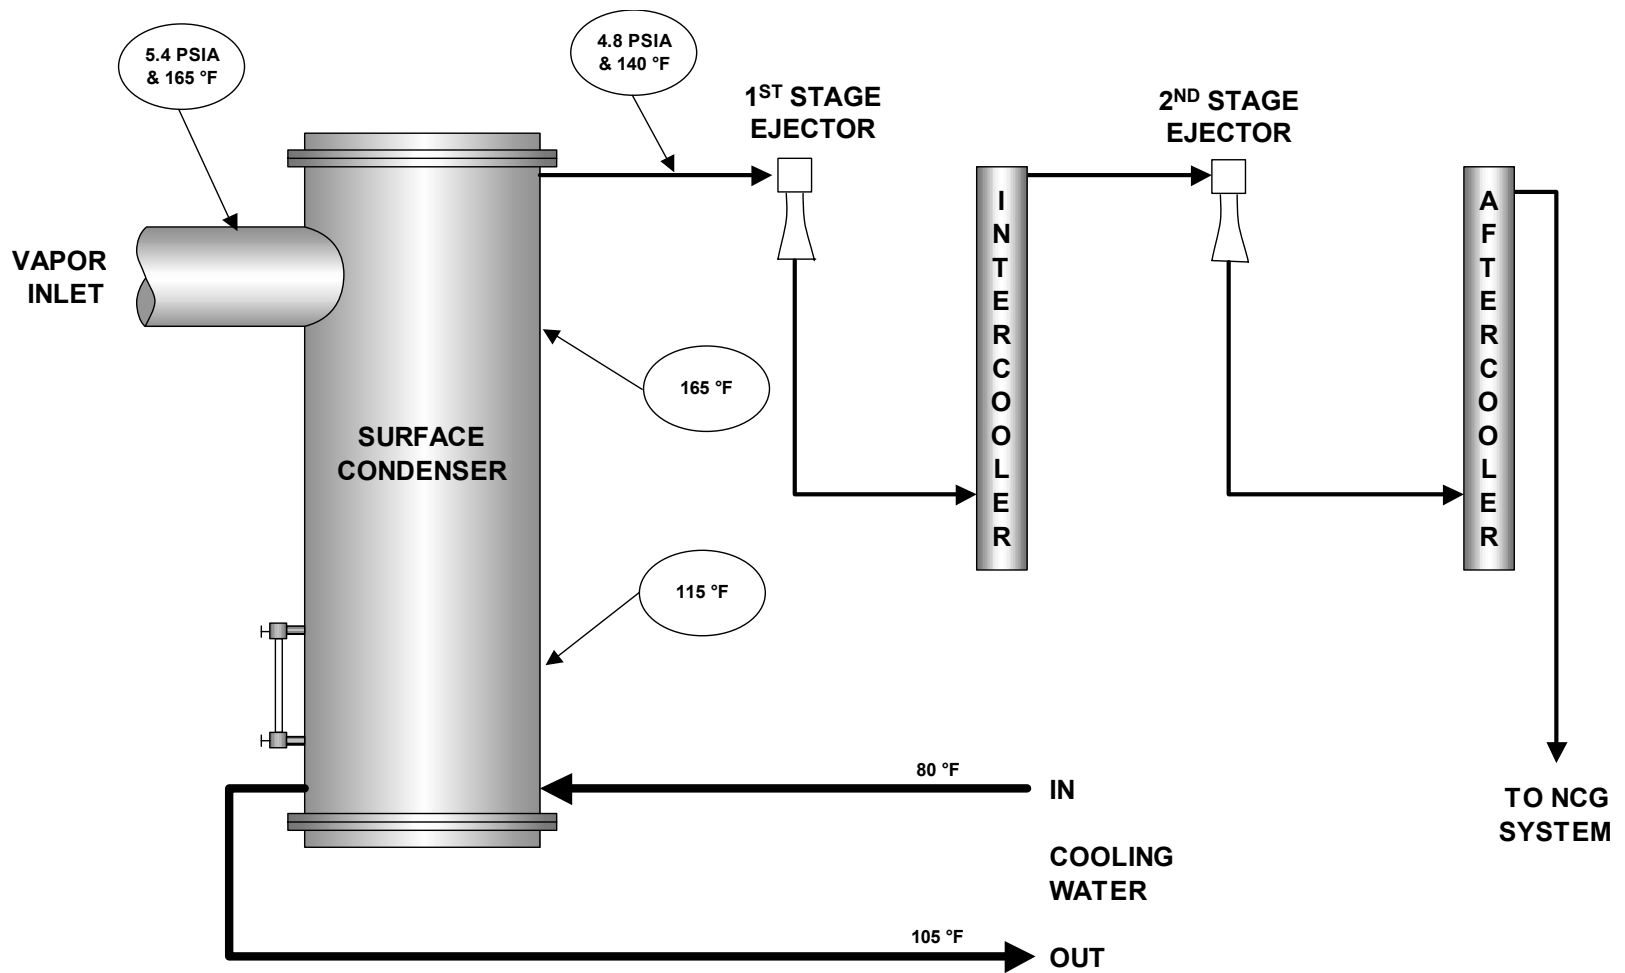
CASE 1 SURFACE CONDENSER WITH EJECTOR SYSTEM – INITIAL DATA

- 1) vapor pressure in the vapor duct immediately before the condenser
- 2) vapor pressure and temperature in NCG line between integral precooler and first stage steam jet ejector
- 3) condenser cooling water inlet and outlet temperatures.

- a) The approach temperature of 33°C (60°F) greatly exceeded the expected value of approximately 11°C (20°F), indicating that the condenser heat transfer coefficient was poor.
- b) The gas inlet temperature of 60°C (140°F) at the first stage greatly exceeded an expected value of approximately 32°C (90 °F), indicating that the internal precooler was also not functioning properly.

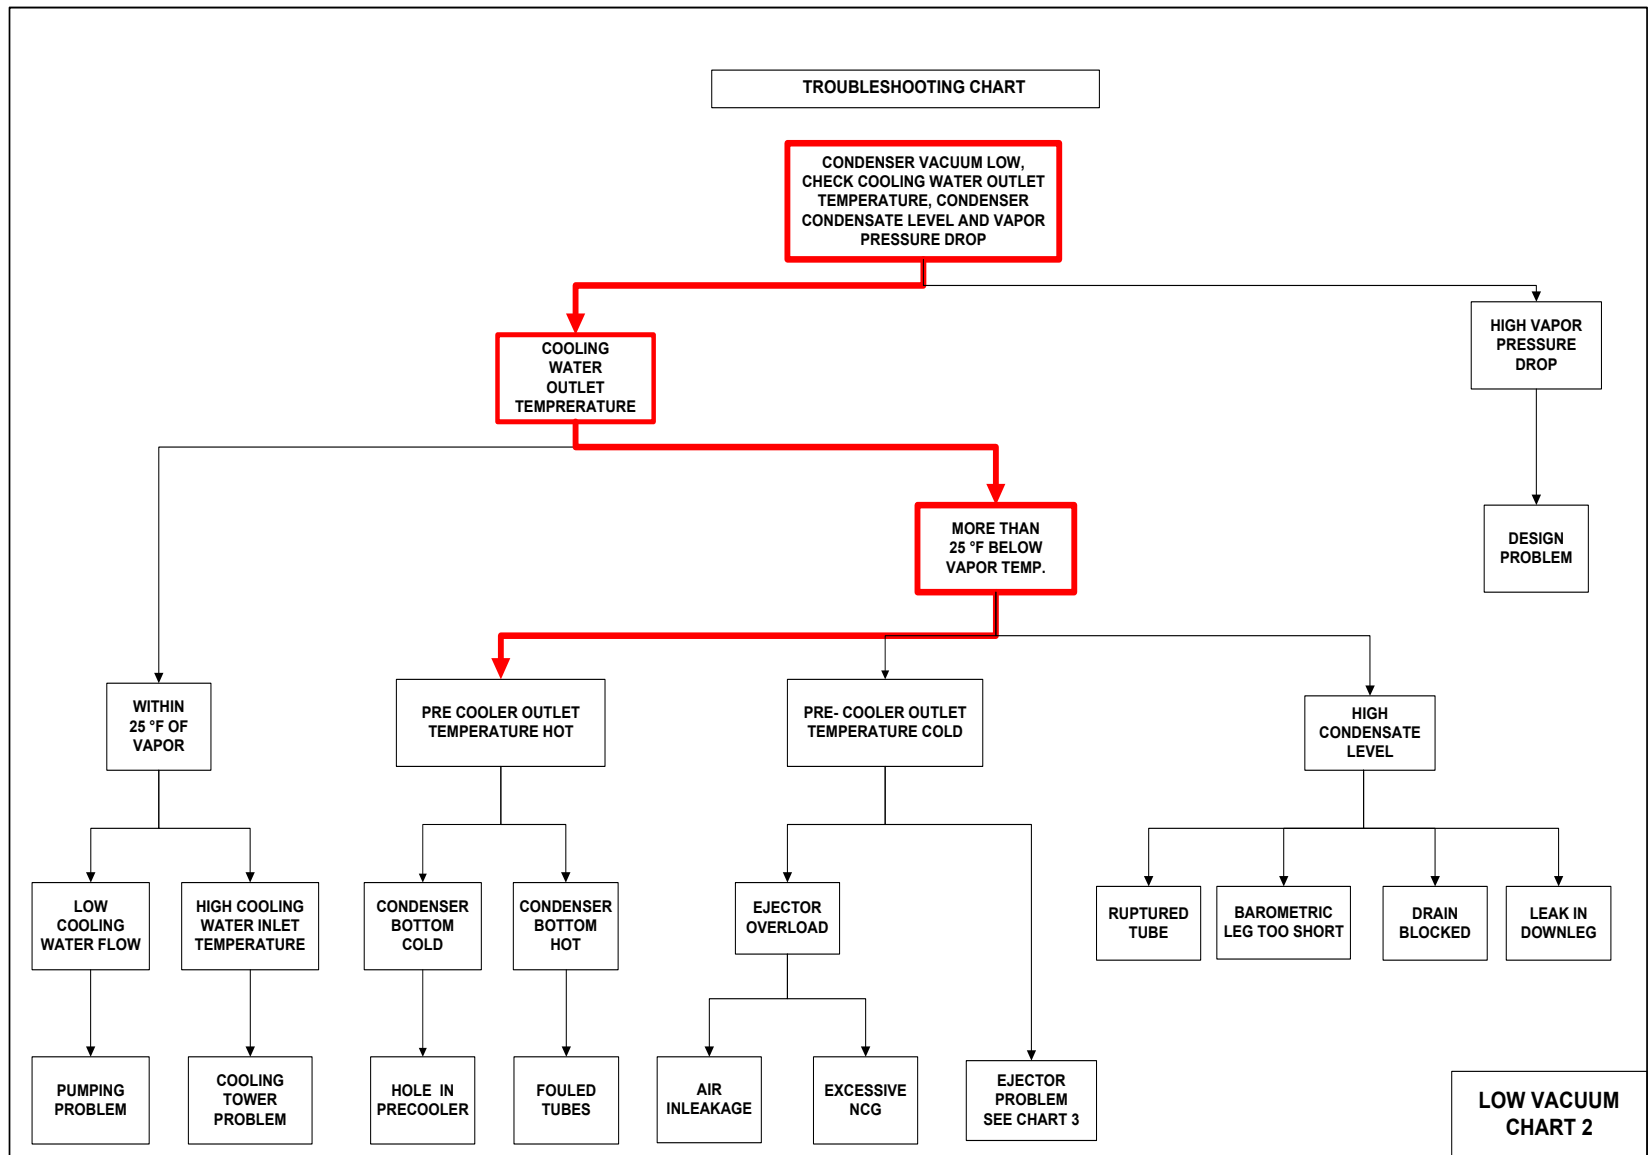
CASE 1 RESULTS FROM INITIAL DATA

The secondary data showed a 28°C (50°F) temperature gradient on the condenser both outside the precooler section and inside the precooler section. This gradient indicated either an accumulation of non-condensable gasses or of condensate in the lower portion of the condenser. The normal condensate level observation ruled out an accumulation of condensate – indicating non-condensable gas accumulation. Again, from the troubleshooting chart indications were that uncooled vapor and non-condensable gasses bypassing the cooler and were venting higher up on the condenser shell. **Slide 5**

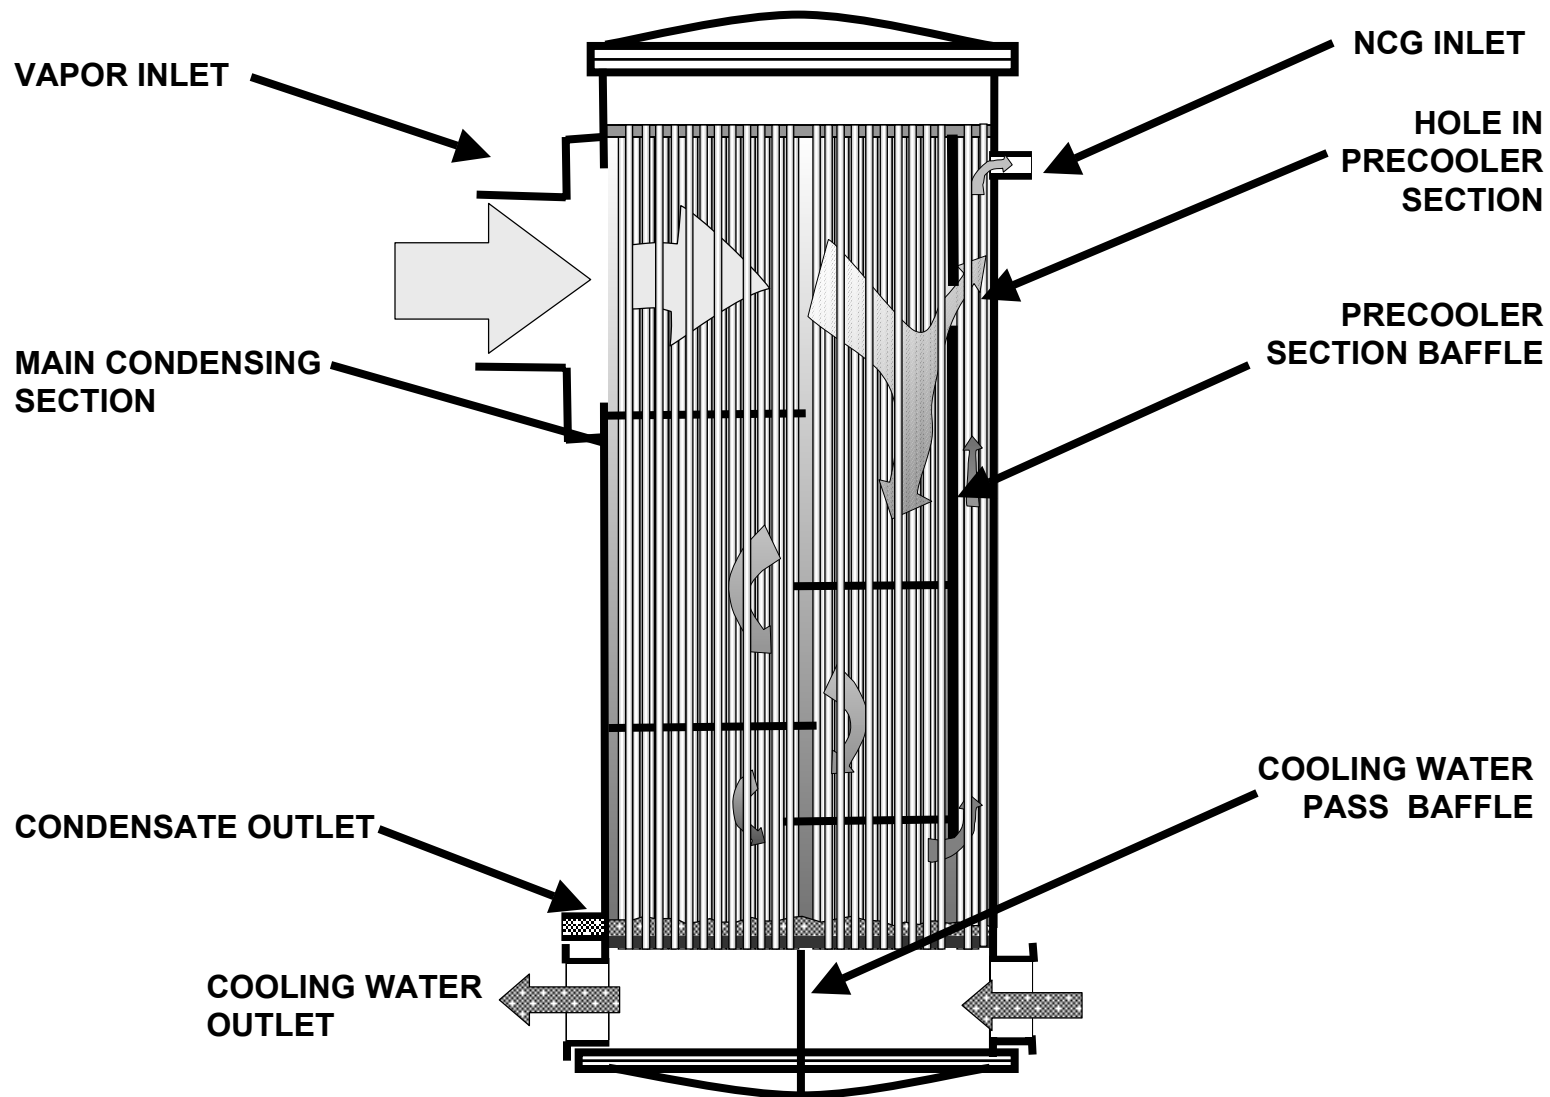
VERTICAL SHELL AND TUBE CONDENSER WITH HOLE IN PRECOOLER CROSS SECTION

In this case, apparently a hole had corroded in the vapor side pass baffle and allowed vapor from near the top of the condenser to flow directly into the precooler section without having first gone through the main condensing section. The vapor bypass allowed a large volume of vapor to enter directly into the first stage steam jet ejector and prevented non-condensable gases in the lower portion of the cooler from escaping. **Slide 6**

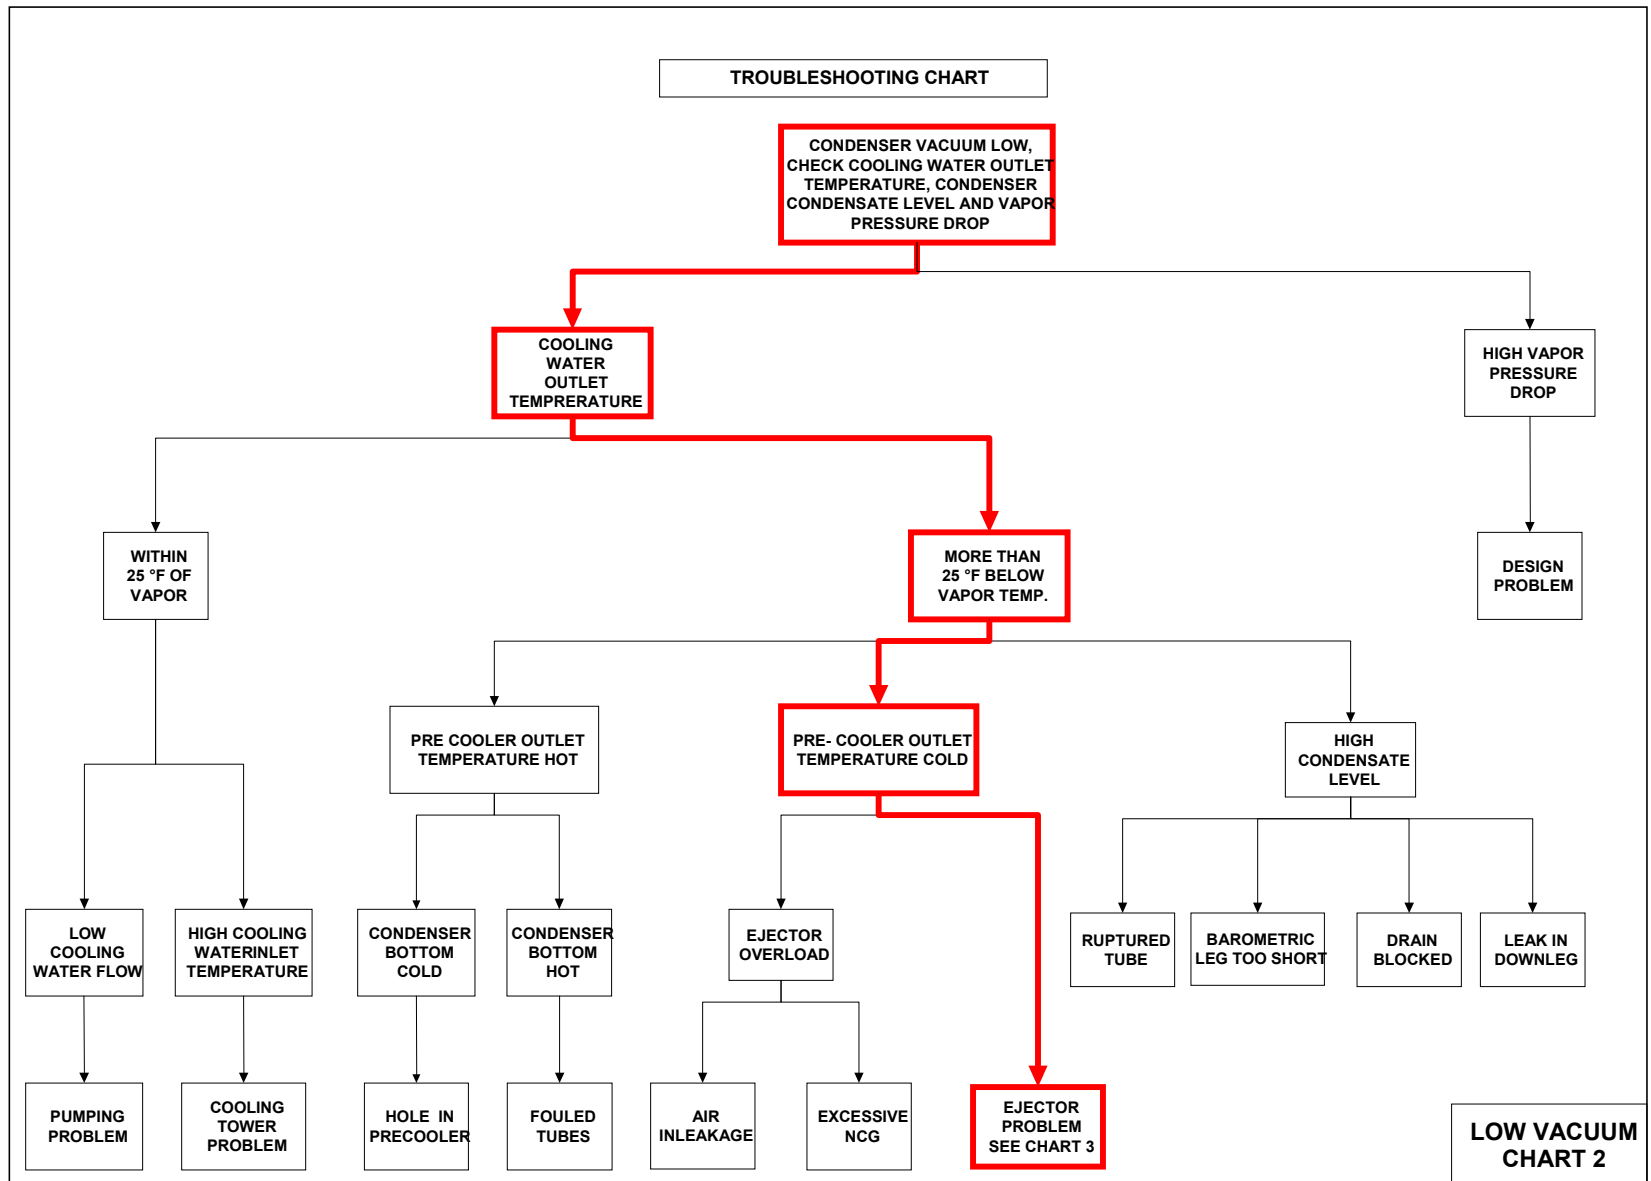
CASE 2 RESULTS FROM INITIAL DATA

- a) The approach temperature of 58°C (105 °F) greatly exceeded the expected value of approximately 11°C (20°F), - indicating that the condenser heat transfer coefficient was poor.
- b) The low temperature of gases approaching the first stage jet indicated that the internal precooler was functioning normally.

The troubleshooting chart indicated that either the ejectors were overloaded with excess NCG or there was a physical problem with the steam jet ejectors. **Slide 11** If an NCG overload existed, it would have most likely been caused by an air leak somewhere in the vacuum effects. Finding a vacuum leak usually requires an extended outage for a hydrostatic test of some kind to find. The decision was made to try to first determine if there were problems with the ejectors.

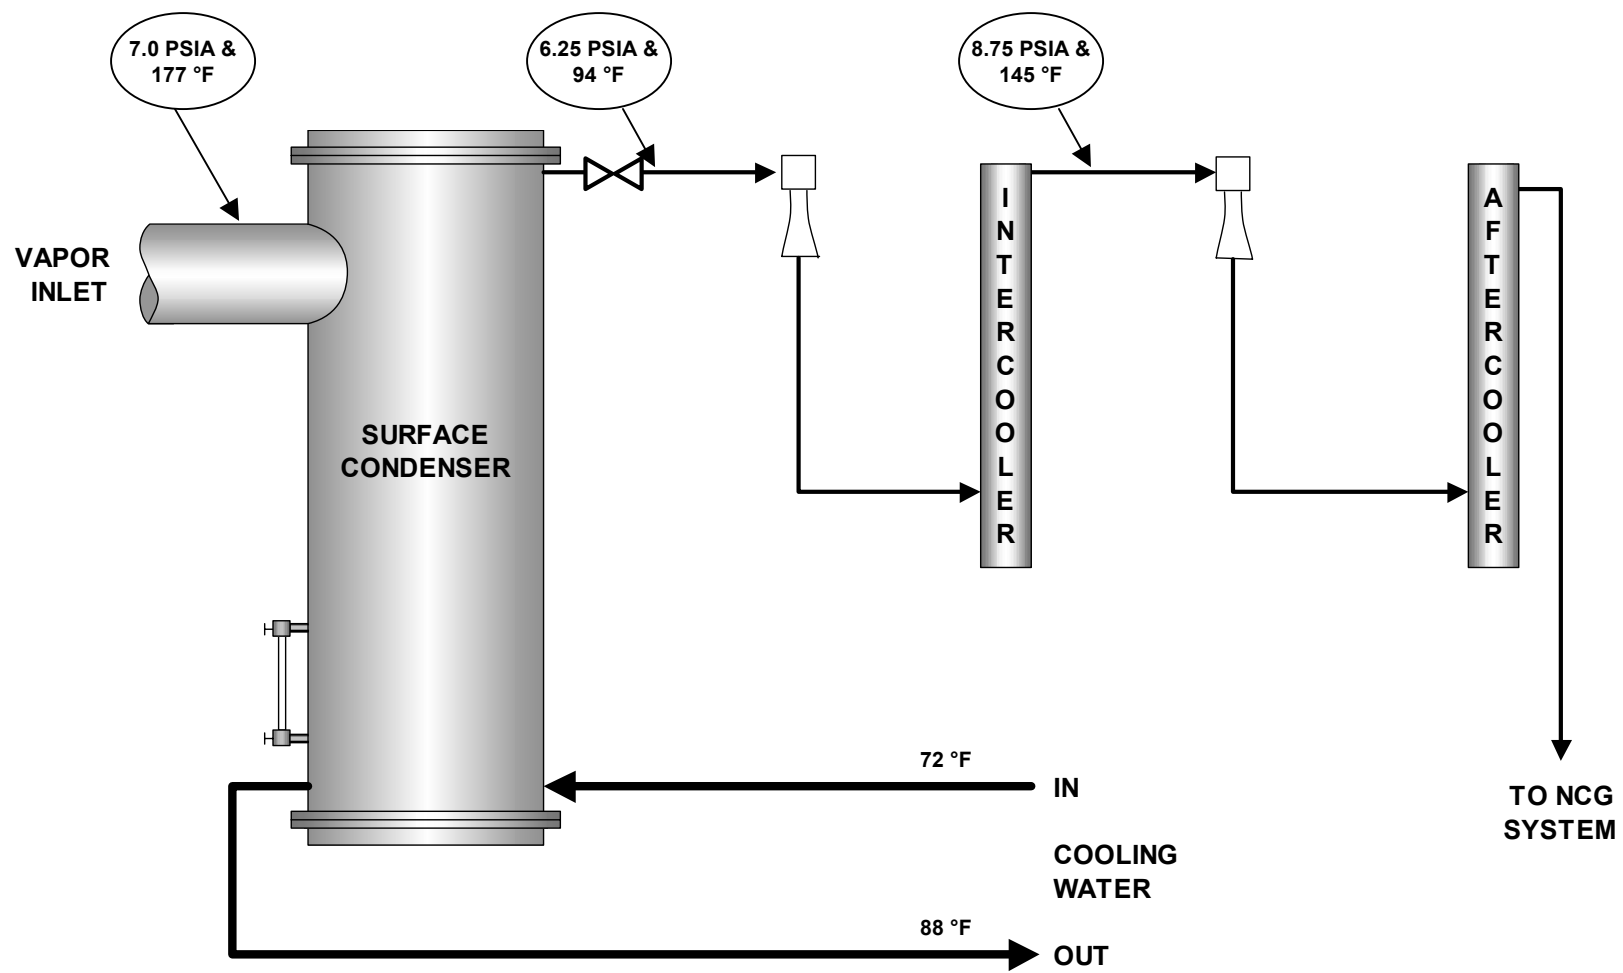
**CASE 2 SURFACE CONDENSER AND VACUUM SYSTEM
INITIAL DATA**

The first set of data collected was similar to that collected in case 1 - vapor pressure in the vapor duct immediately before the condenser, vapor pressure and temperature immediately before the first stage steam jet ejector, vapor pressure immediately before the second stage steam jet ejector and condenser cooling water inlet and outlet temperatures. It was also observed that the condensate level was normal. **Slide 10**

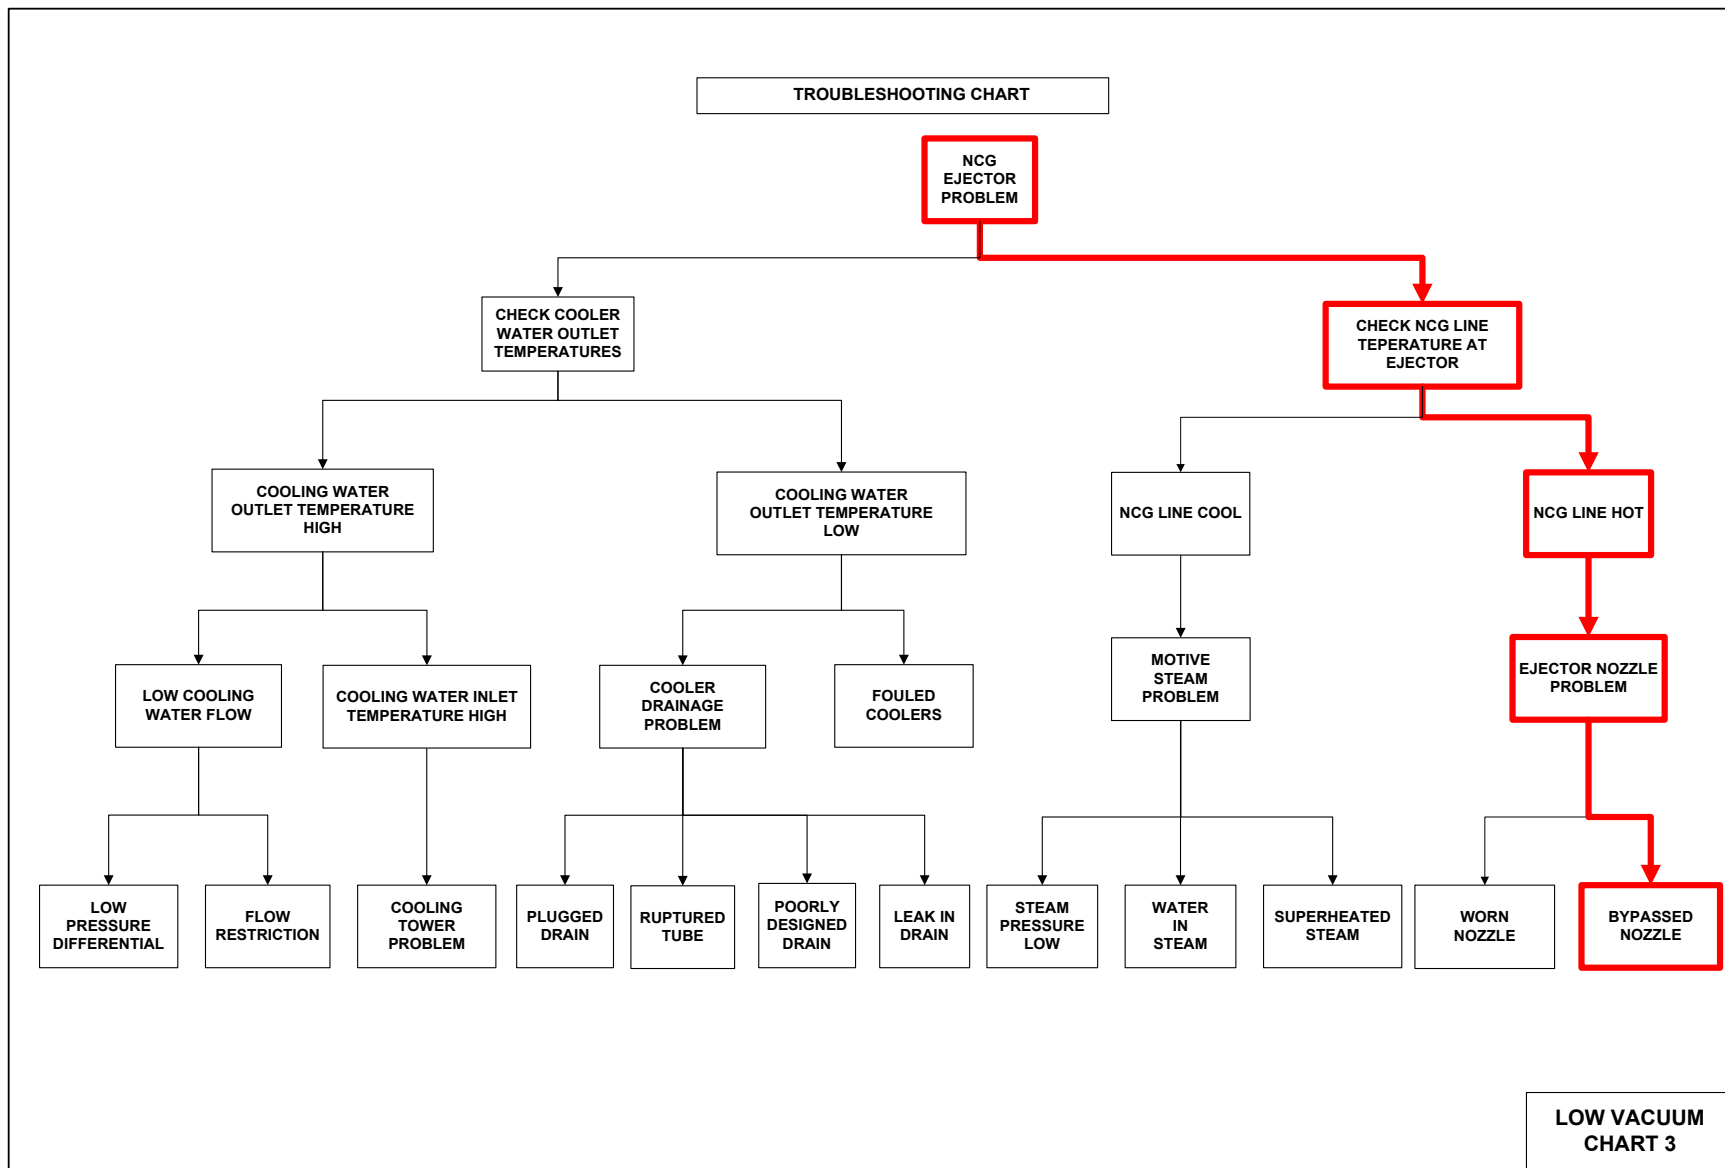
CASE 2 RESULTS FROM SECONDARY DATA

Page 3 of the troubleshooting chart indicated that additional data was required. **Slide 12** The temperature of the NCG line immediately adjacent to the first stage steam jet ejector body was read and found to be 71°C 160 °F. This reading is in contrast to the 34°C (94°F) temperature for the majority of the line. **Slide 13**. The high temperature at the suction of the ejector indicated excessive steam passing through (or around) the steam nozzle. - either because of a worn nozzle or a leak around the nozzle itself.

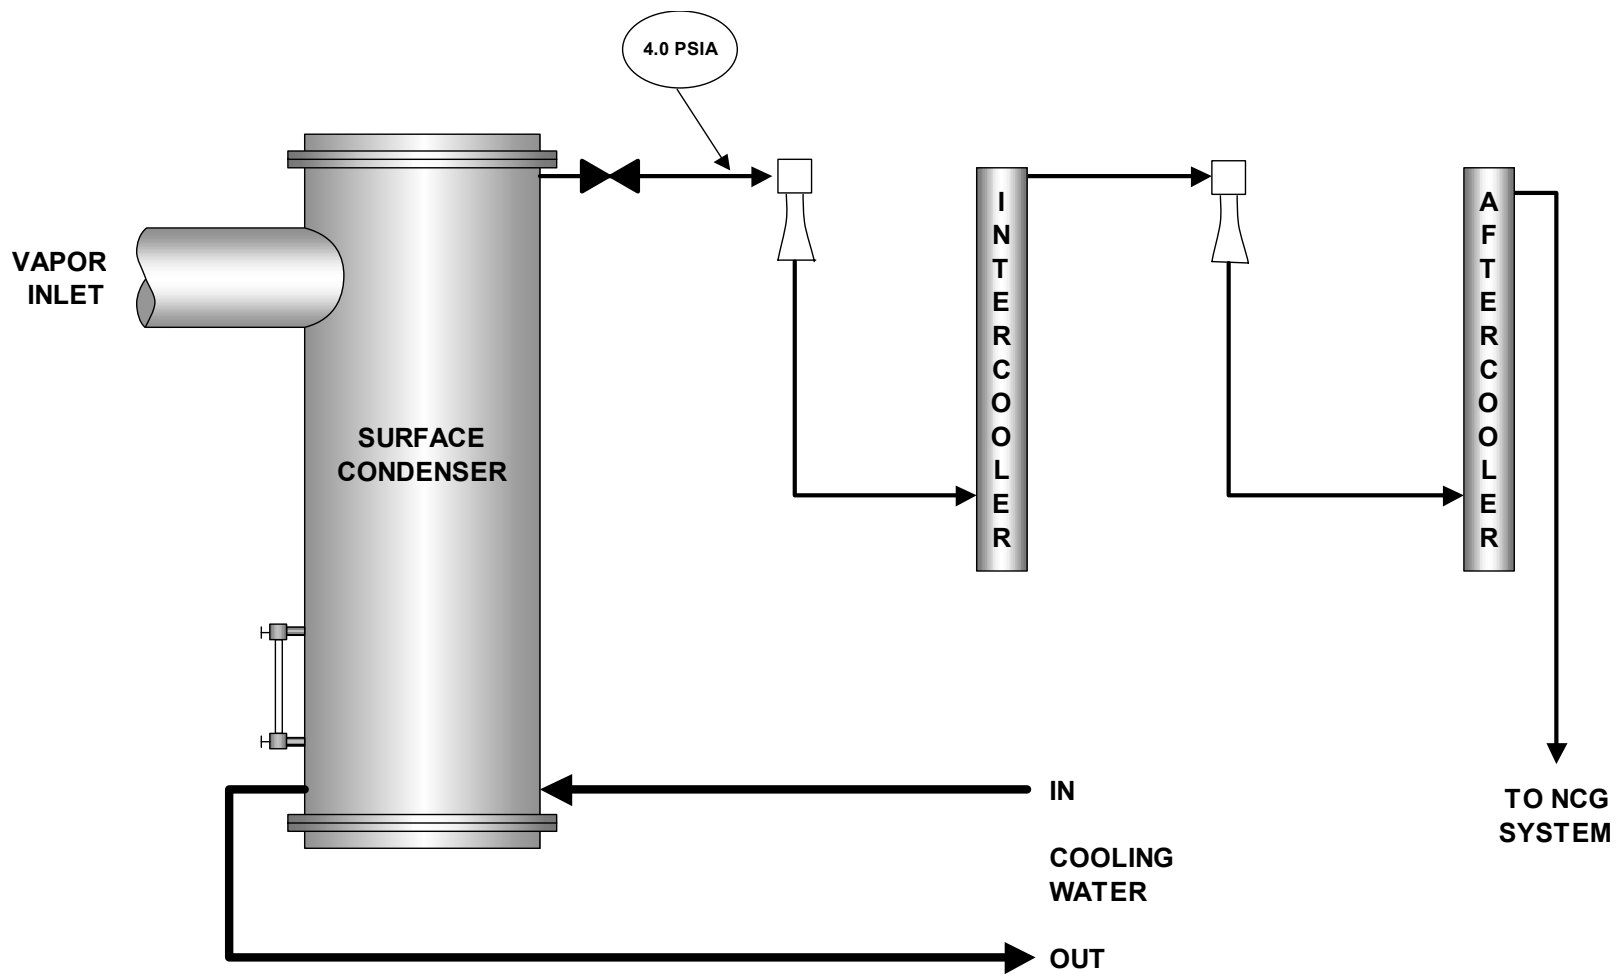
**CASE 2 SURFACE CONDENSER AND VACUUM SYSTEM
DEADHEAD TEST**

Although not listed on the troubleshooting chart, a final test was conducted to verify the preliminary conclusion that a mechanical problem existed with the ejector itself. This test determines the ejectors' vacuum under "deadhead" conditions, i.e. with NCG suction valve closed. This test indicated a maximum vacuum of 28 kPa (4.0 psia). **Slide 14** Normally a two stage ejector can evacuate to an absolute pressure of 5.2 kPa (0.75 psia). At this point it had been determined that the low vacuum was due to a mechanical problem with the ejector - most likely due to a worn steam either nozzle or steam bypassing the nozzle.

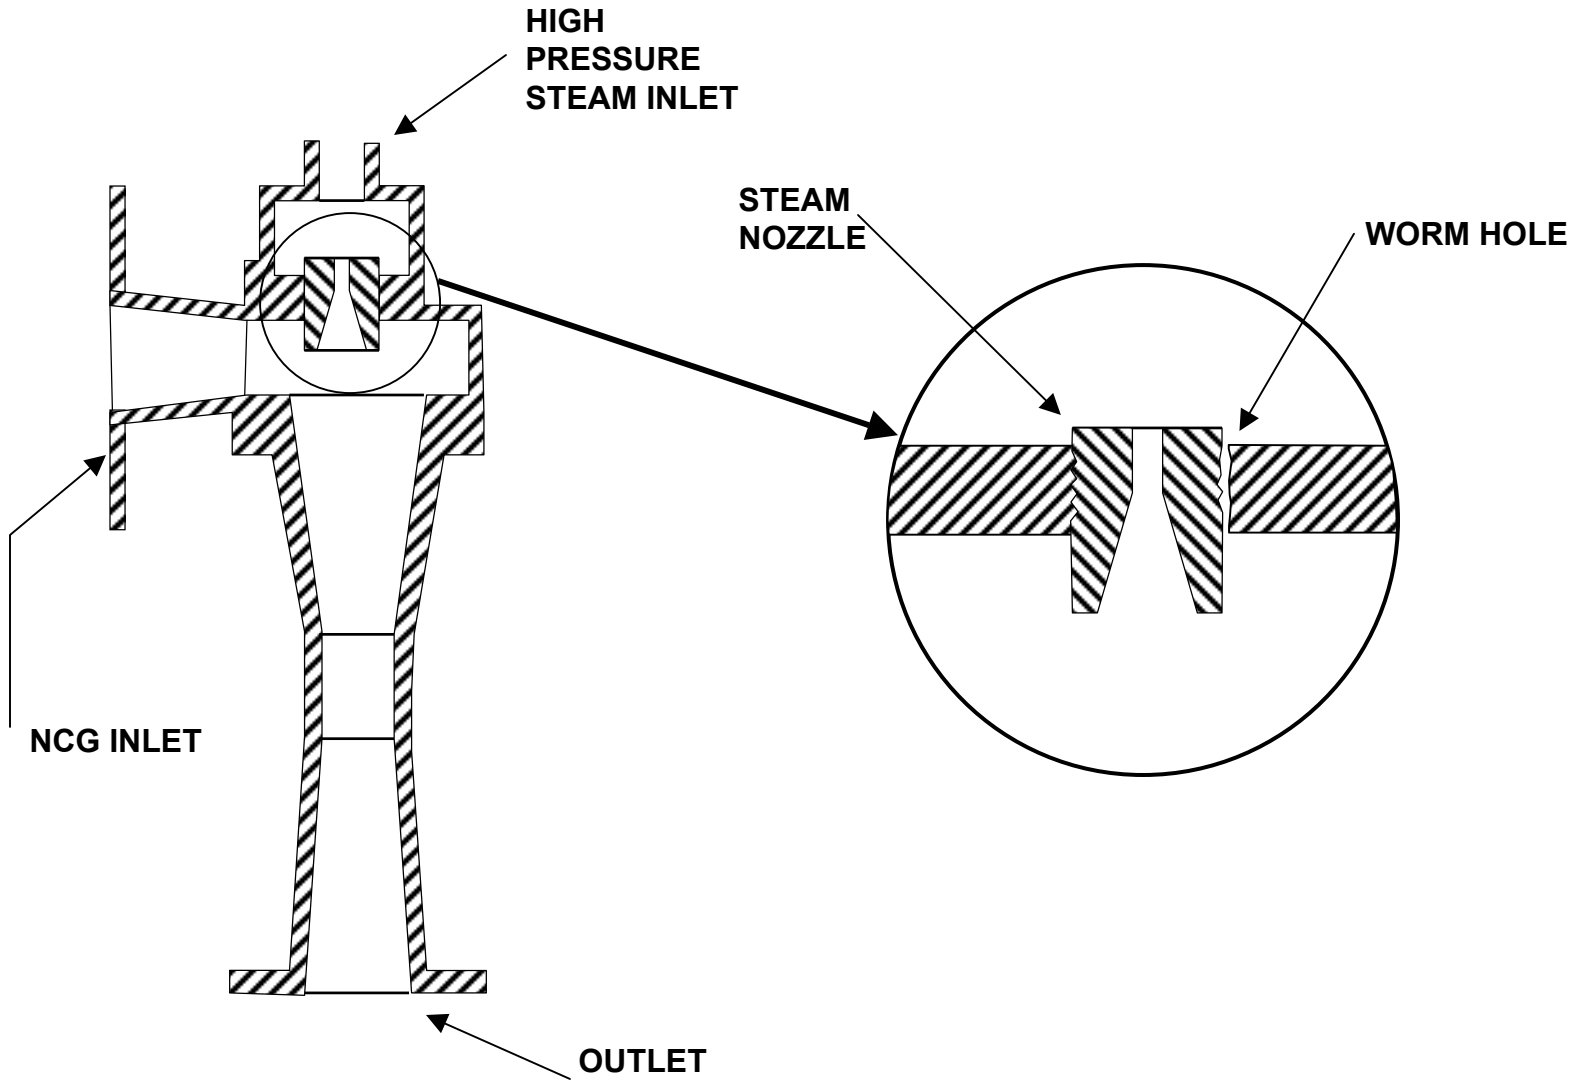
STEAM JET EJECTOR CROSS SECTION

The evaporator was shut down and the first stage ejector was disassembled. A "wormhole" was observed in the ejector housing around the steam nozzle. **Slide 15** The "wormhole" is caused by a small steam leak through the threaded portion of the housing. The flow of the high pressure steam through the leak erodes the metal and forms a path for a significant amount of steam to bypass the nozzle.

After the repair, the evaporator was restarted and it was able to operate at near design vacuum and capacity.
