Troubleshooting Two Vacuum Problems

Alton Goodwin
Process Engineering, Inc.
Birmingham, AL 35201

INTRODUCTION

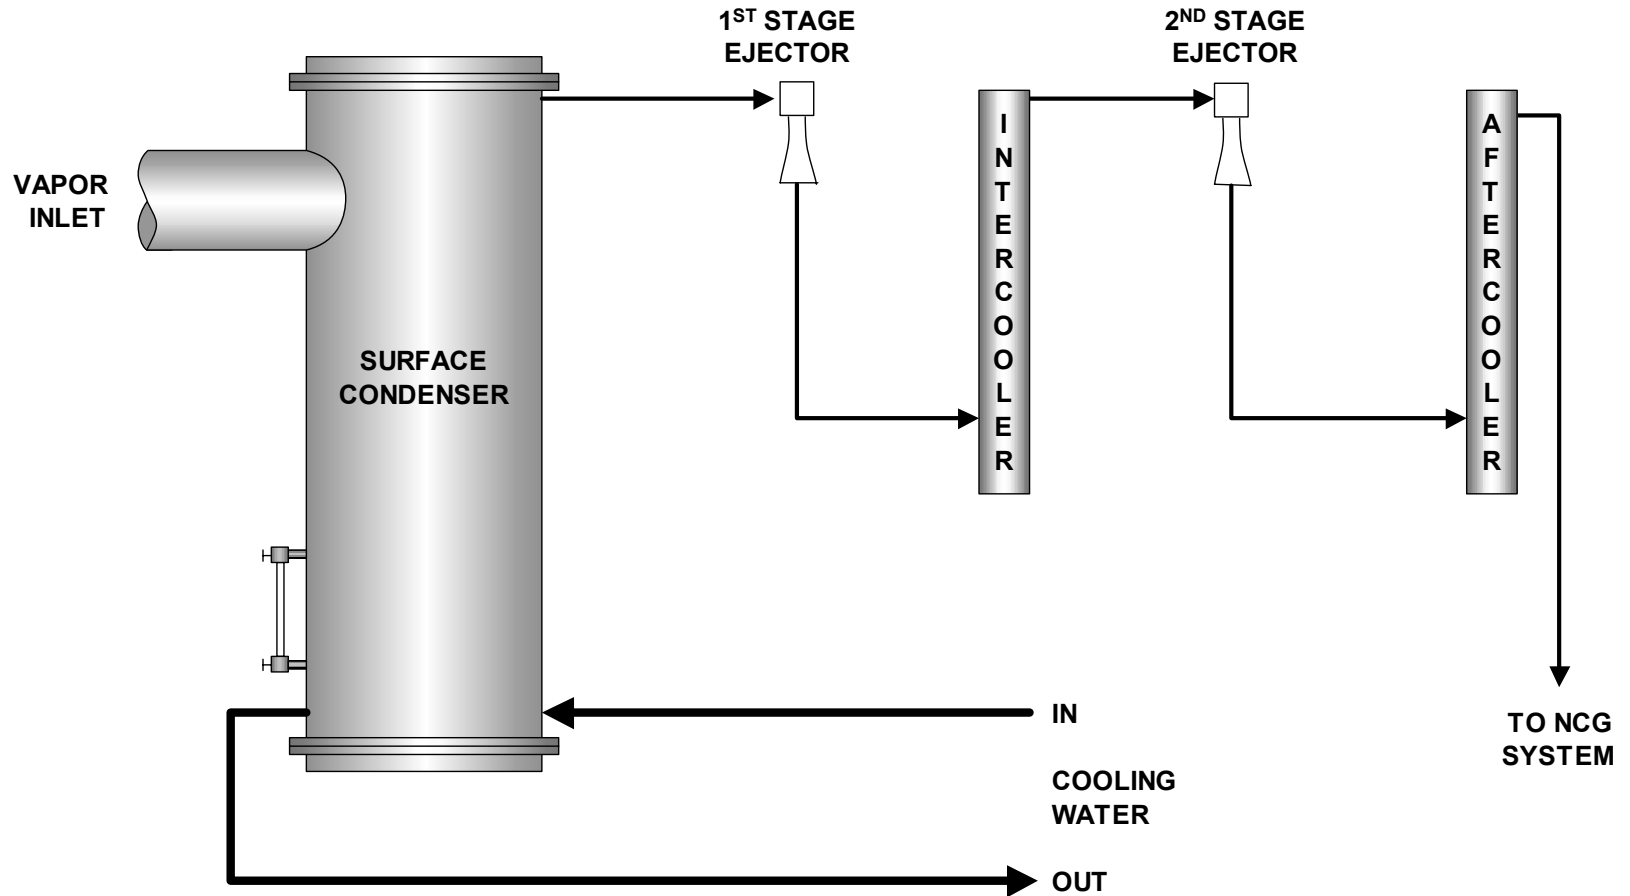
CASE 1 SURFACE CONDENSER AND VACUUM SYSTEM CONFIGURATION

Case 1 occurred at a major southern Kraft mill where the customer noted a gradual condenser vacuum loss and corresponding capacity loss. The condenser and vacuum system consisted of a single surface condenser with an integral precooler, a two stage steam jet ejector with indirect contact intercooler and aftercooler. **Slide 1**

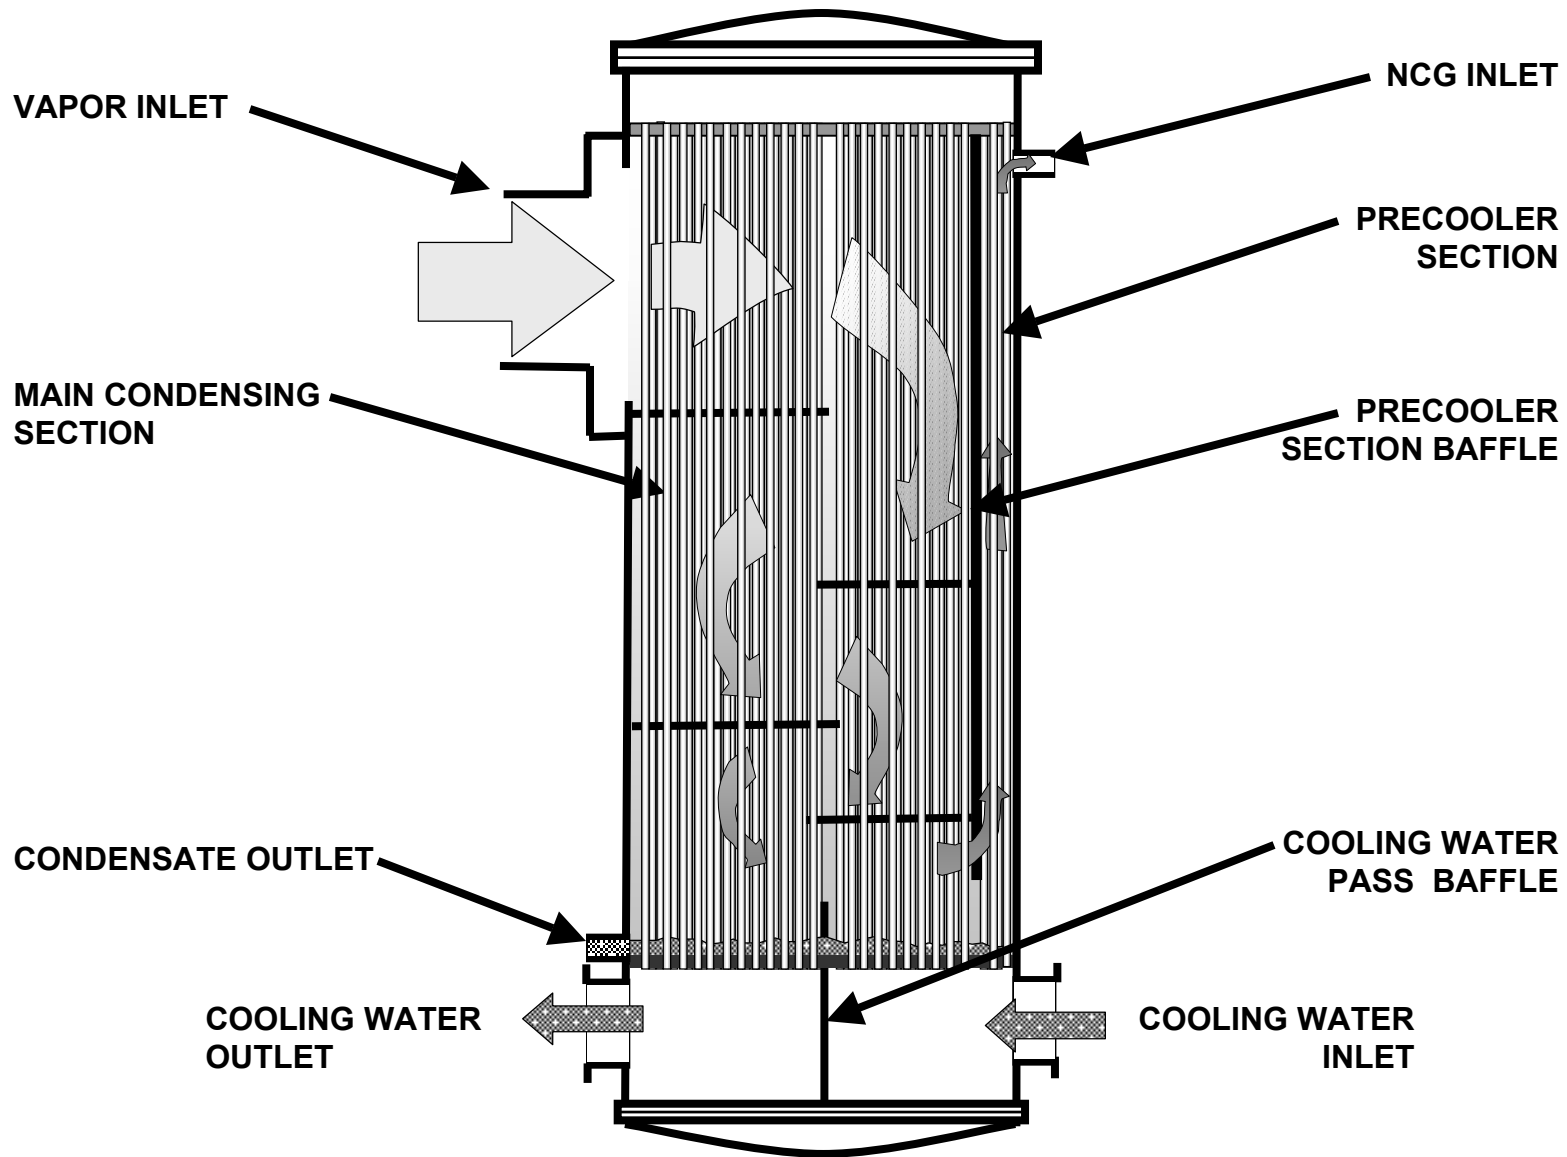
**VERTICAL SHELL AND TUBE CONDENSER WITH INTEGRAL PRECOOLER
CROSS SECTION**

It should be noted here that a temperature profile of the condenser shell can be a powerful tool in evaluating surface condenser operation. For this case, with a top vapor entry condenser, one would expect there to be a small temperature gradient vertically from top to bottom for most of the shell. For that area of the shell containing the precooler, one would expect a larger gradient to be reversed and somewhat greater. The vapor temperature at the precooler section should be at vapor saturation temperature, and the vapor temperature at the top of the precooler section to be within ~five°C (ten °F) of the cooling water inlet temperature.
